ALFA 159 1.9 JTD 16V CHECK OF DAMPER CORRECT ORIENTATION 4420AG

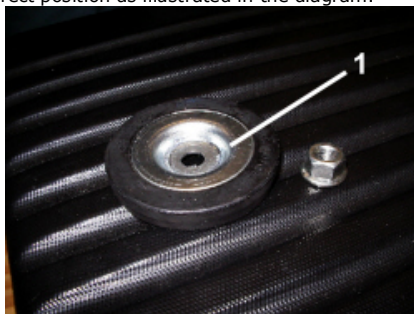
1. Check that the buffer plate is fitted in the correct position as illustrated in the diagram.

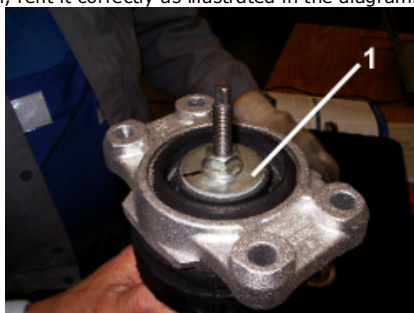
1. If the plate is not fitted in the correct position, refit it correctly as illustrated in the diagram.
