ALFA 159 1.9 JTD 16V TAILGATE SELF-ADJUSTING BUFFERS - R.R. 7015B12

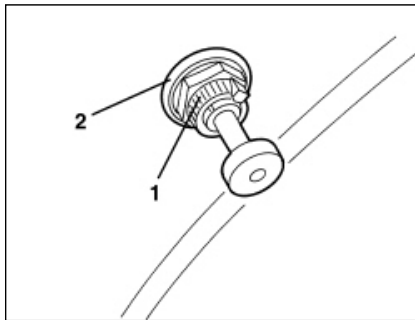
1. Undo the end of travel buffers ring nut.

2. Remove the buffers from the housings in the tailgate using a screwdriver for leverage and raising the support plane.

The buffers removed cannot be reused.

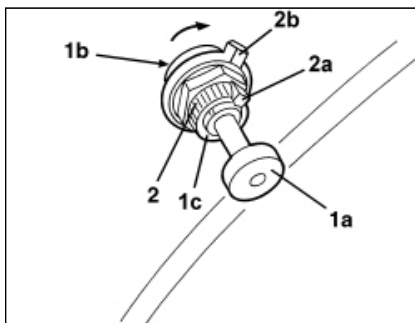
1. Fit the new buffers (1a) in place, without rotating the ring nut (1b) in relation to the base (1c).

Place the mounting base (1c) in contact with the panel.

There is only one mounting fitting position.

During this stage the end of travel buffers adjust themselves by means of a movement inside their moving casing.

2. Rotate the ring nut (1c) clockwise through around 340° until it is aligned with the references (2a and 2b) on the ring nut and on the base.
